# #6635 - EOW - Lower Road WD3 5LA

2025-05-09

Lower Road, Chorleywood Bottom,  
 Chorleywood, Rickmansworth, UK

Water Damage Report, Trace & Access Survey

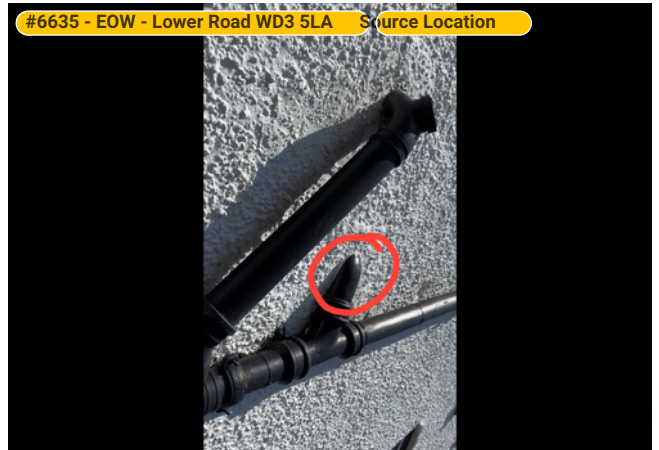
#6635 - EOW - Lower Road WD3 5LA Source Location

High moisture levels above picture rail on staircase wall are the result of a suspected crack in the hideaway cistern toilet cast iron bend inside the solid brick wall. This can't be 100% confirmed till the toilet stud wall is knocked down and the cast iron pipe completely exposed. However we have found evidence of blown pebble dash around the soil pipe bend which backs up our assumption of a cracked pipe inside the wall.

The bathroom toilet should not be used going forward till the suspected leak is fixed. Once the toilet wall is removed and the cast iron soil pipe exposed, the cast iron bend needs cutting out which will involve erecting a scaffold tower to safely remove the top section of soil pipe because this can't be safely left in place and change the tee fitting below.

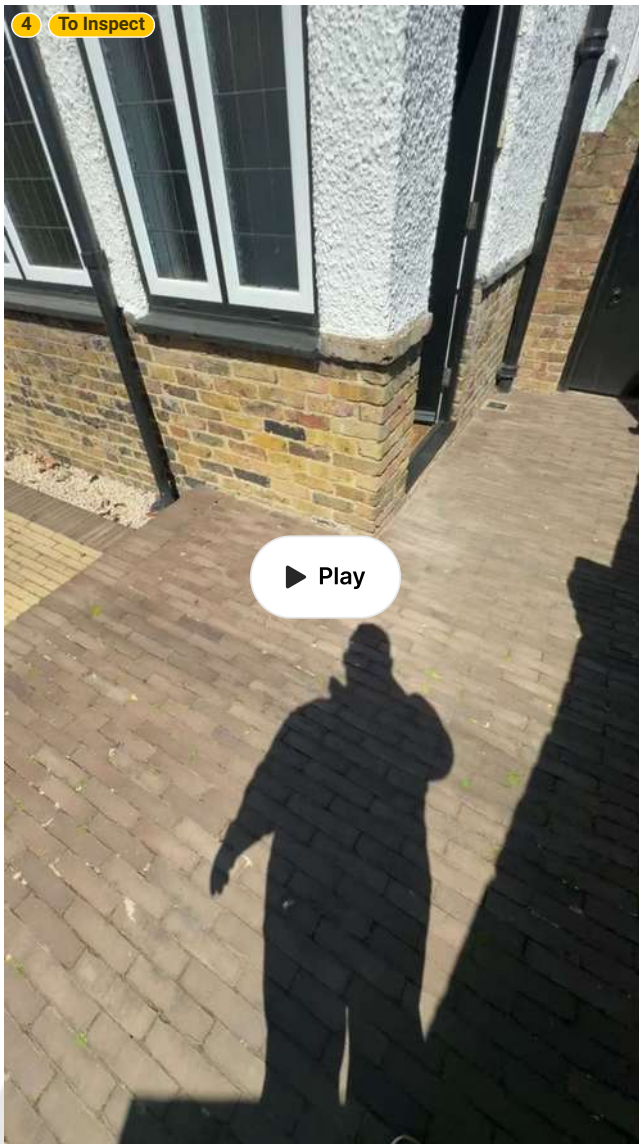
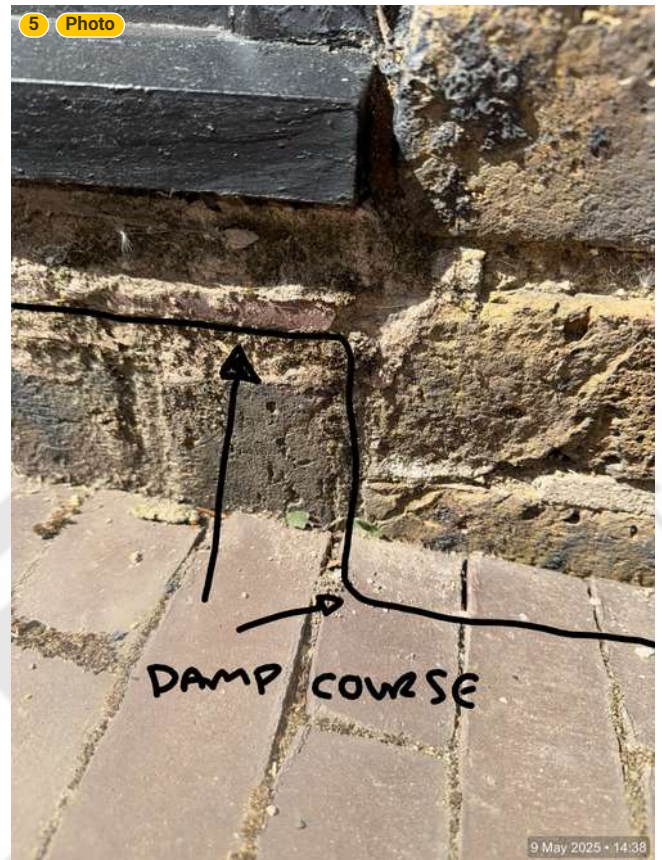
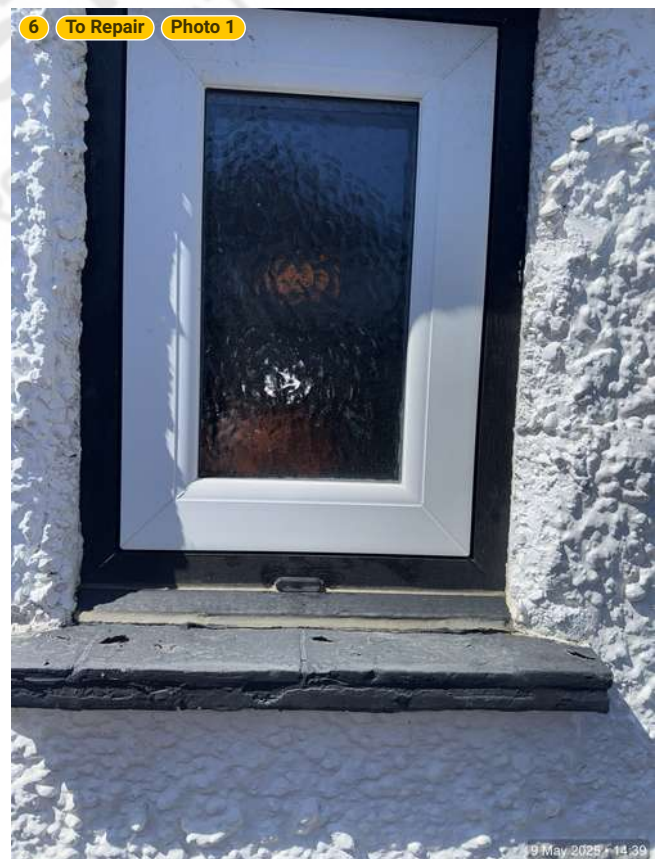
Bridged damp course at low level due to high external ground level.

Installation of an aco drain around the perimeter of the flank wall and porch where the DPC level is below the recommended 150mm

Installation of a French drain system or similar

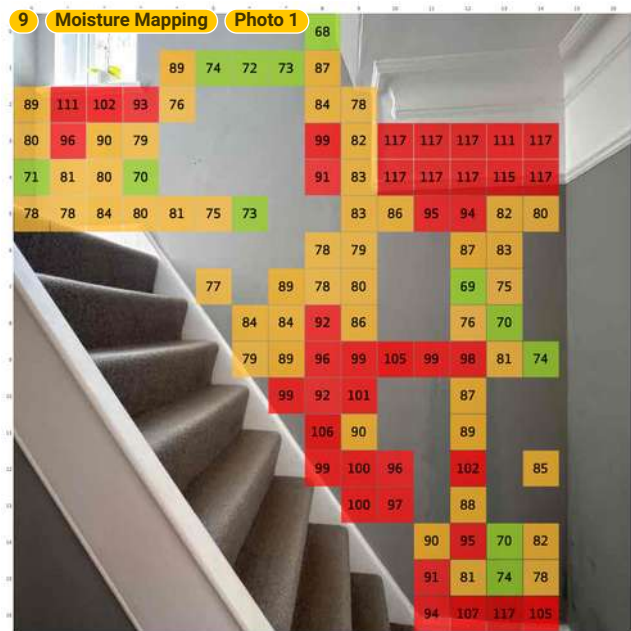
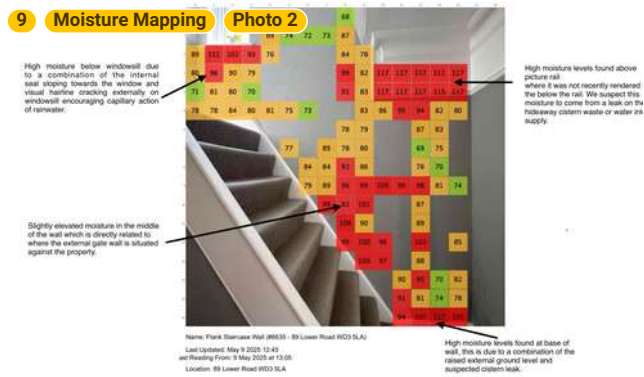
Name: Flank Staircase Wall (#6635 - 89 Lower Road WD3 5LA)  
Last Updated: May 9 2025 12:45  
Last Reading From: 9 May 2025 at 13:05  
Location: 89 Lower Road WD3 5LA

Moisture mapping of internal side of flank wall (staircase wall) revealed multiple issues contributing to the visual and non-visual damp.

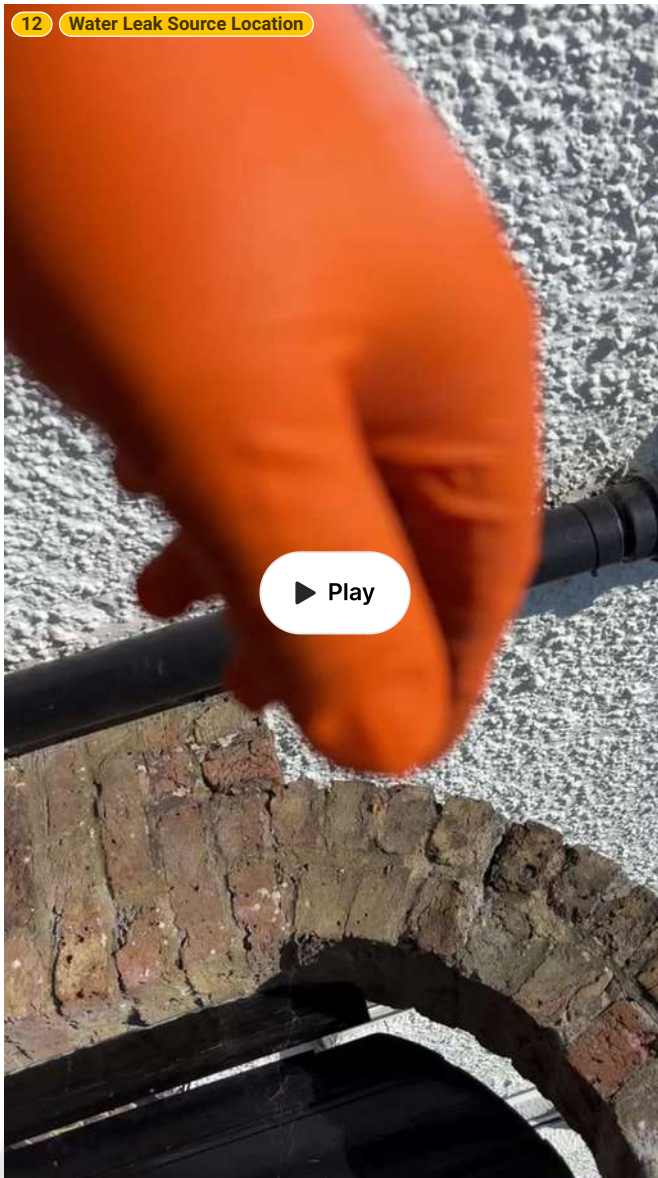
#### 12 WATER LEAK SOURCE LOCATION

Suspected crack on cast iron soil pipe inside the external wall behind hideaway cistern frame.

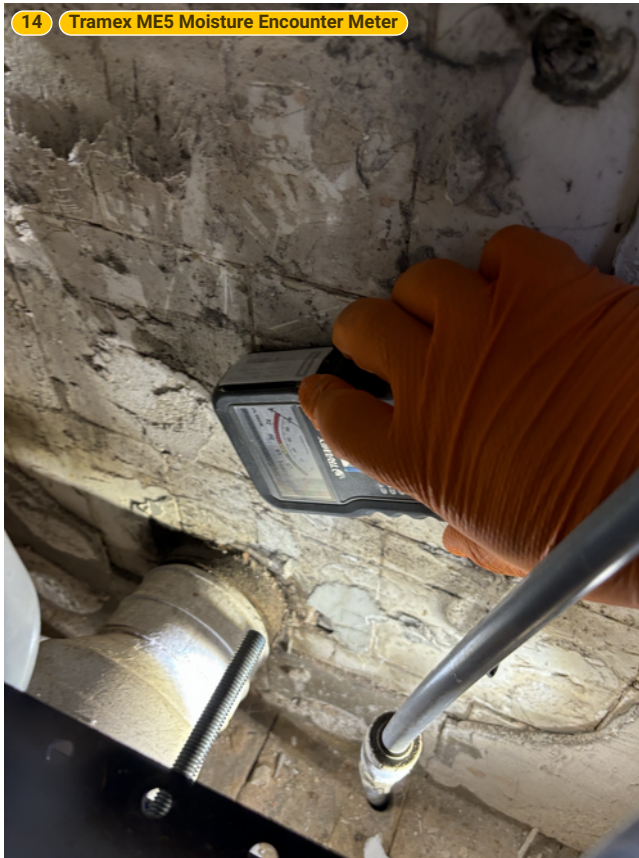
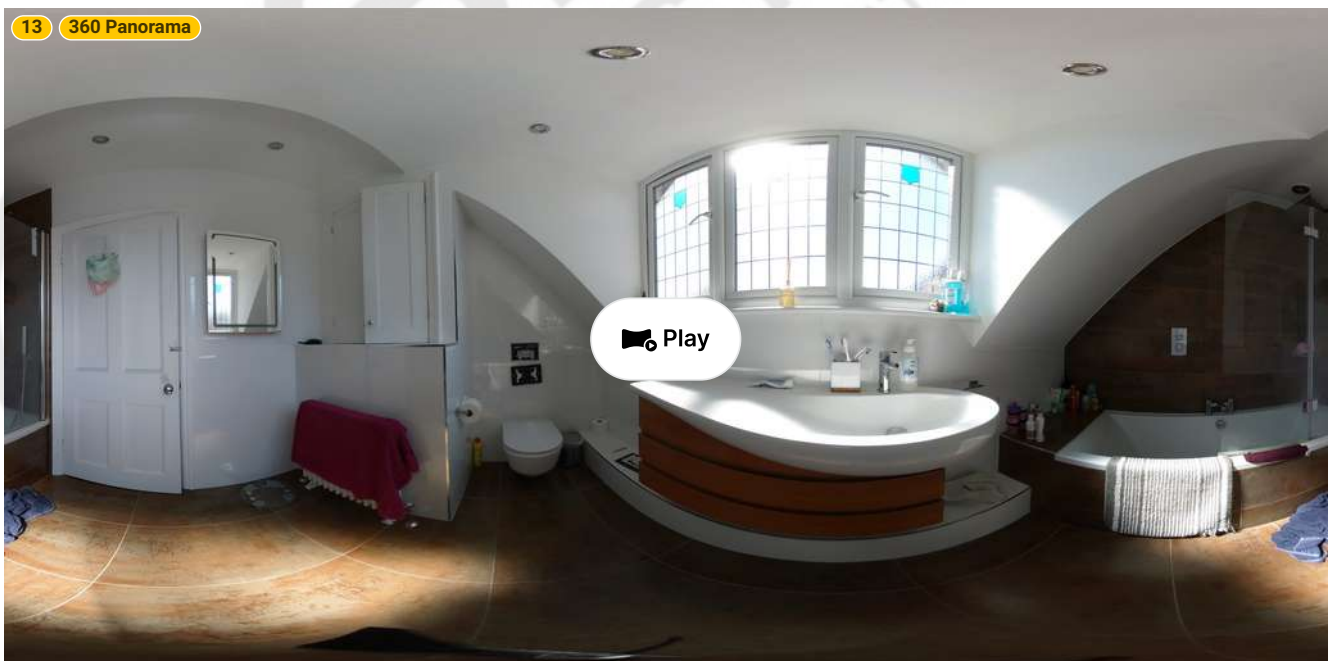
#### 14 TRAMEX ME5 MOISTURE ENCOUNTER METER

Tiles removed to access behind hideaway cistern, high moisture readings found above and around cast iron pipe inside wall, waste connection from pan to cast iron pipe looks fine with no visual leak.
